Manhole Inspection Summary

Manhole # S49A__053MH

Insp Date: **5/8/08 8:13 AM**

Location Address: **439 n lakewood**

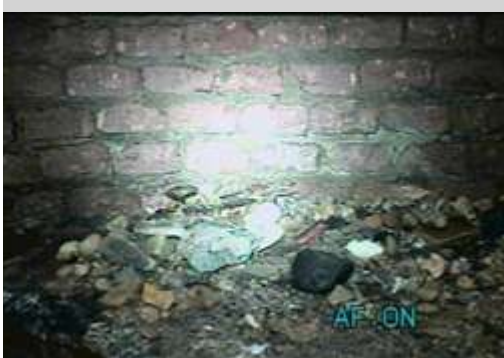
Misc

bench debris

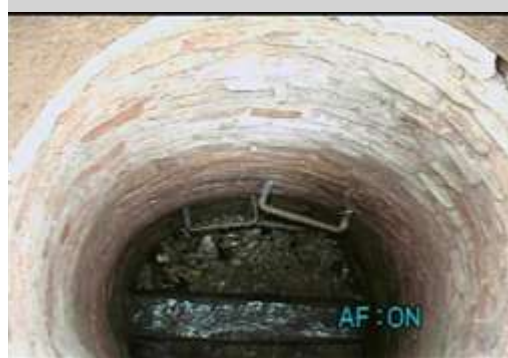
Defect 2

Steps Count: **5** Missing: **2** ☒ **Corroded**

steps missing 2, corroded

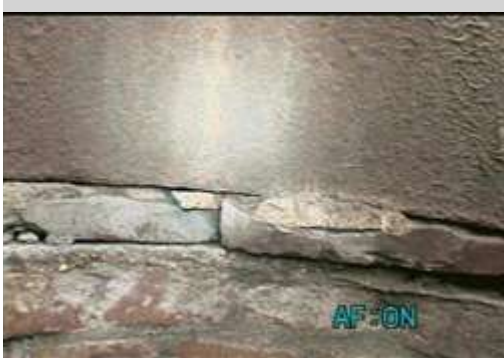
Defect 1

Condition: ☐ Sound ☐ Cracked ☐ Root Intrusion ☒ **Loose Brick** ☐ Deteriorated

loose bricks, frame adjustment

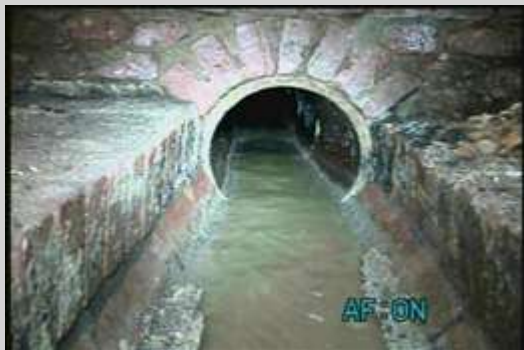
12 O'Clock Outflow

10 in. Circular Gravity Sewer
Pipe Out @ 12 O'Clock

Pipe Material: **Clay** ☐ Pipe Lined

Invert Depth: **10.35** (ft.) Flow Characteristics: **Fast**

Infiltration: **None** Pipe Seal Cond: **Unknown**

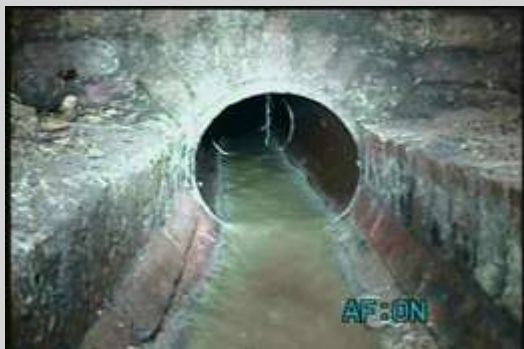
6 O'Clock Inflow

10 in. Circular Gravity Sewer
Pipe In @ 6 O'Clock

Pipe Material: **Clay** ☐ Pipe Lined

Invert Depth: **10.27** (ft.) Flow Characteristics: **Fast**

Infiltration: **None** Pipe Seal Cond: **Unknown**
